# Manhole Inspection Summary

Manhole # S07MM1013MH

Insp Date: **6/23/09 12:31 PM**

**Location** Address: **3326 W GARRISON AVE**

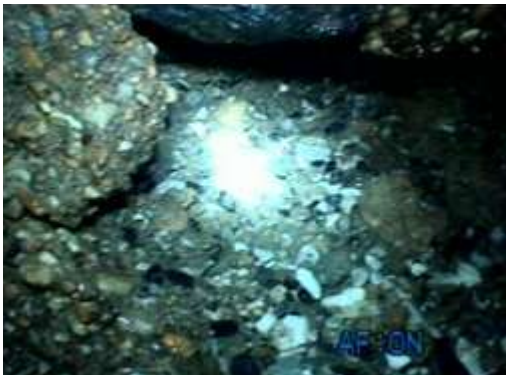
Defect 1

Condition: ☐ Sound ☐ Cracked ☐ Root Intrusion ☐ Loose Brick ☒ **Deteriorated**

HOLE/ VOID IN BARREL WALL

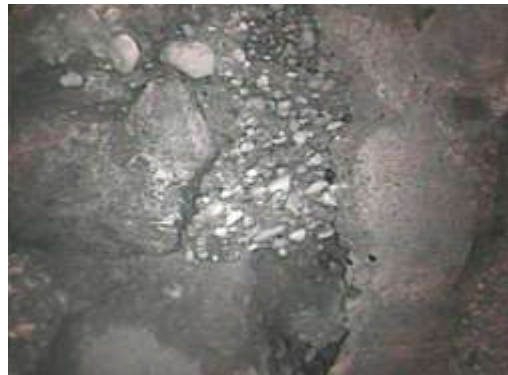
Defect 2

Condition: ☐ Sound ☐ Cracked ☐ Root Intrusion ☒ **Deteriorated** ☐ Leaks ☒ **Debris**

DEBRIS/DETERIORATION ON BENCH

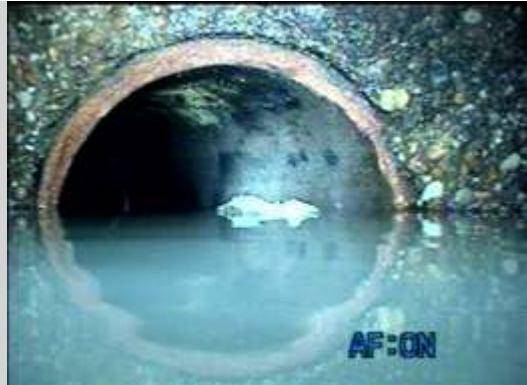
12 O'Clock Outflow

12 in. Circular Gravity Sewer  
Pipe Out @ 12 O'Clock

Pipe Height: **8.4** (in.) Rod and Bar  
Pipe Material: **Clay** ☐ Pipe Lined  
Invert Depth: **13.08** (ft.) Flow Characteristics: **Slow**  
Deposits: ☒ None ☐ Mud ☐ Sludge ☐ **Debris** ☐ Grease  
Silt Depth: (in.) Deposits Extent:  
Infiltration: **None** Pipe Seal Cond: **Sound**

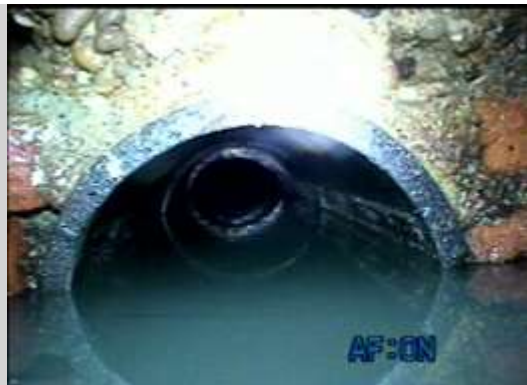
3 O'Clock Inflow

8 in. Circular Gravity Sewer  
Pipe In @ 3 O'Clock

Pipe Height: **4.8** (in.) Rod and Bar  
Pipe Material: **Clay** ☐ Pipe Lined  
Invert Depth: **13.02** (ft.) Flow Characteristics: **Slow**  
Deposits: ☒ None ☐ Mud ☐ Sludge ☐ **Debris** ☐ Grease  
Silt Depth: (in.) Deposits Extent:  
Infiltration: **None** Pipe Seal Cond: **Sound**

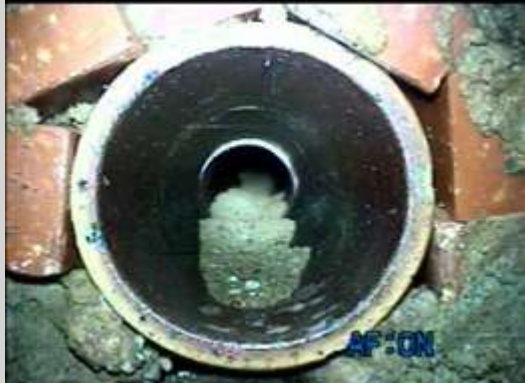
9 O'Clock Inflow

10 in. Circular Gravity Sewer  
Pipe In @ 9 O'Clock

Deposits: ☐ None ☐ Mud ☐ Sludge ☒ **Debris** ☐ Grease

Silt Depth: **2** (in.) Deposits Extent: **Light**

Pipe Seal Cond: **Broken**
